Repair Macintosh SE/30

This web site will show symptoms, diagnoses, solutions and preventions for various hardware troubles of Macintosh SE/30.

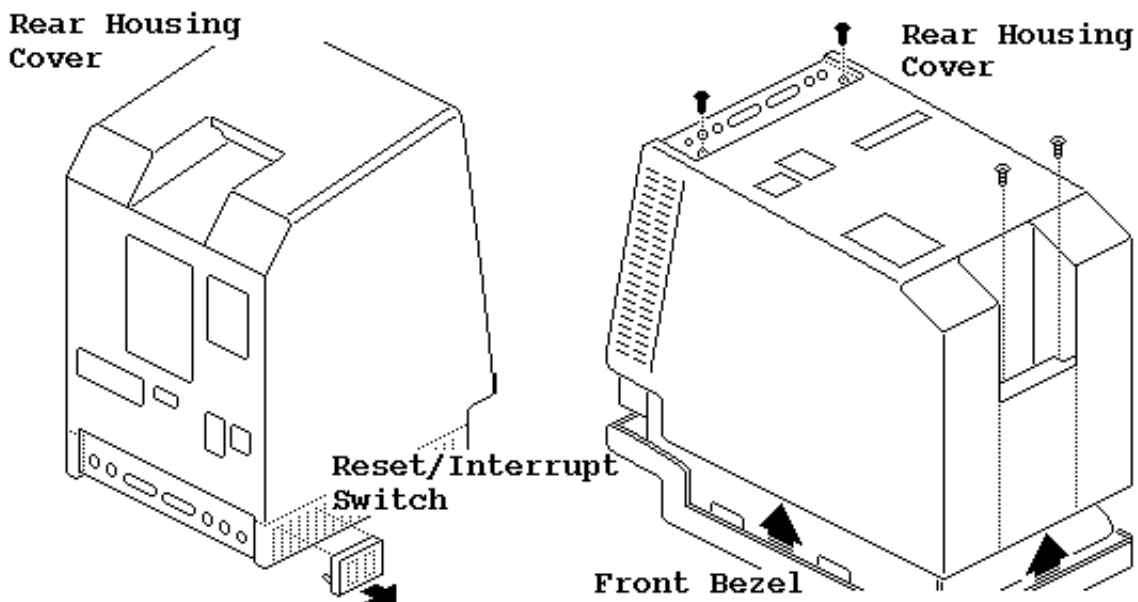
- (1) Using a small screwdriver, pry off the reset/interrupt switch on the left side of the case.
- (2) Using a long Torx screwdriver, remove the four case screws and separate the rear housing cover from the chassis with a pull-apart tool.
- (3) Carefully lift up the rear housing cover and set it aside.

- (4) Remove the paper insulating shroud from the bottom of the computer. It may come out with the rear housing cover.

Reinstall the two black case screws in the bottom of the cover and the two silver-colored case screws in the

top of the cover.

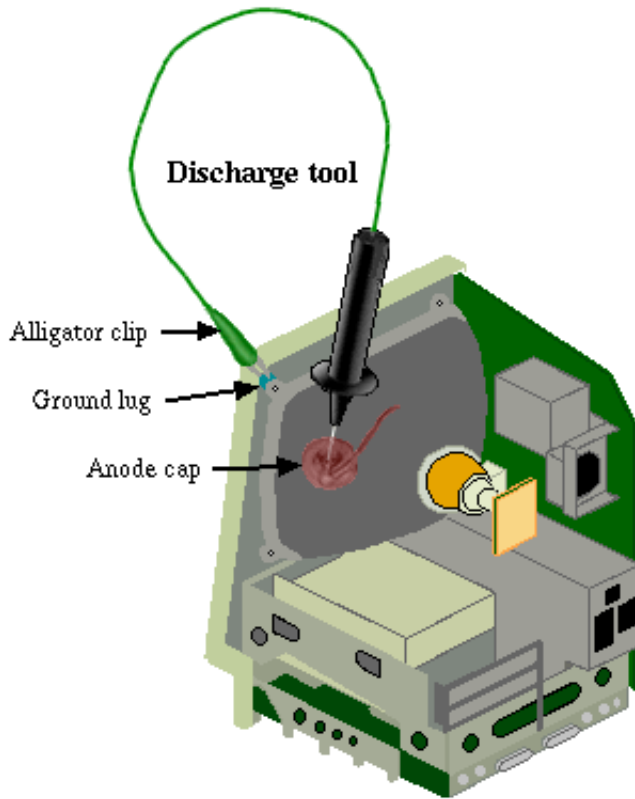
3. Discharge CRT

If you are working on a compact Mac that contains a CRT (just like SE/30) and incorrectly discharge the CRT to the metal chassis, you may destroy the logic board.

You must discharge to the ground lug!
YOU MUST DISCHARGE TO THE GROUND LUG!

(1) Attach the clip of the CRT discharge tool to the ground lug of the Mac.

(2) Touch the discharge tool probe to the anode aperture.
(2-1) Put one hand behind your back, and grasp the handle of the discharge tool with your otherhand.
(2-2) Hold the CRT discharge tool to the tube surface, and slide the tool probe under the anode cap until the probe touches the anode aperture.
(2-3) Remove the probe of the CRT discharge tool from under the anode cap.

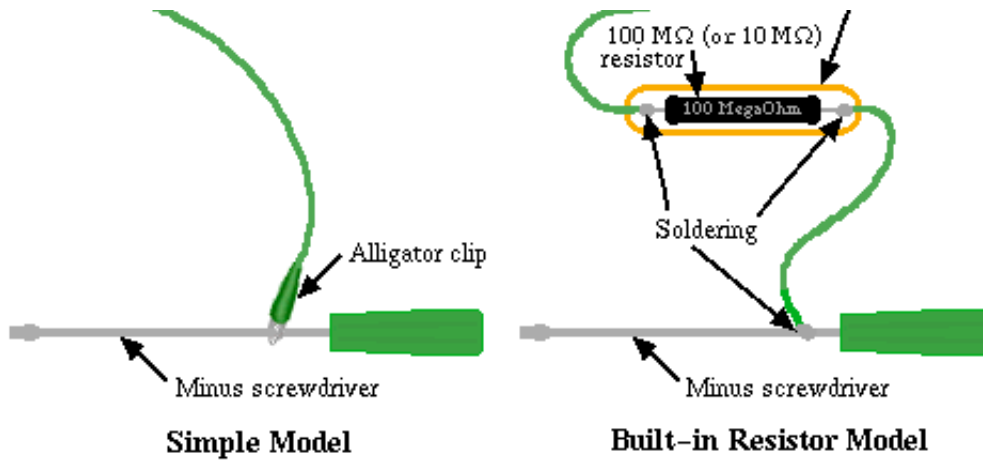
But you can make a discharge tool with a screwdriver, clips, a 100 (or 10) meg ohm resistor, a ballpoint pen shaft (the outer tube of a ballpoint pen) and some wires. Insulating the resistor and its leads with the ballpoint pen shaft prevents careless short between the anode and other components.

The Simple Model and the Built-in Resistor Model in the left figure are corresponding to the Apple Newer and Older Discharge Tools, respectively.

One version is the Apple CRT Discharge Tool (Part No. 076-0381) for later compact Macs and monitors. This version features a stainless steel alligator clip, thicker insulation, and a hand guard. No internal resistor is installed, so the tool gives auditory feedback (the electrostatic crack) to assure the technician, when discharging any monitor without a bleeder resistor, that the CRT is indeed discharged.

The other one is the older version of the Apple CRT Discharge Tool (Part No. 076-0243). The older version has a copper alligator clip but no hand guard. It has a built-in 100-megohm resistor, which means you will not hear an electrostatic crack when the CRT discharges, even if the monitor has no bleeder resistor. This older tool was designed for the original Macintosh or Macintosh Plus logic board. A resistor was installed to diminish the impact of the electrostatic discharge if a technician accidentally discharged the CRT to the metal chassis instead of to the ground lug. (The Macintosh logic board circuitry is grounded to the chassis.) This older tool is safer for use on the Macintosh or Macintosh Plus CRT.

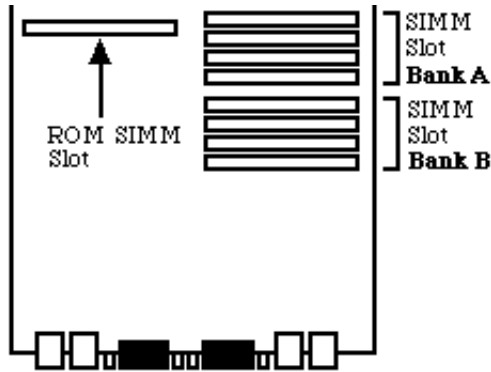
(1) Pull out the ROM-SIMM from the ROM-SIMM slot. Clean the ROM-SIMM and the ROM-SIMM slot with volatile cleaner or ethanol. Then connect the ROM-SIMM to the ROM-SIMM slot correctly and tightly.

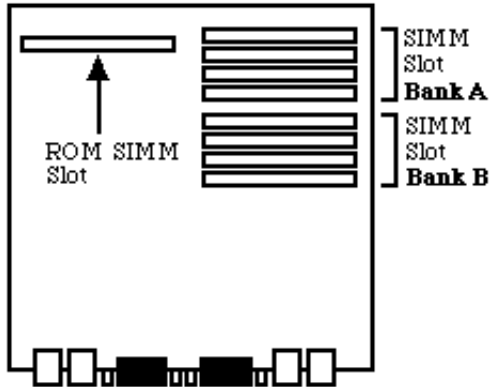
The SE/30 has eight RAM-SIMM slots on the logic board: Four slots at Bank A and four slots at Bank B.

The diagram shows the internal memory layout of a Mac SE/30. It features a ROM SIMM Slot at the top left, indicated by an arrow. Below it are two banks of SIMM slots: Bank A (top) and Bank B (bottom). Each bank contains four slots. The bottom of the diagram shows the physical layout of the slots with their respective pin counts (16, 30, 72, 72, 30, 16).

Total Memory	Bank A	Bank B
1MB	256KB x 4	Empty
2MB	256KB x 4	256KB x 4
4MB	1MB x 4	Empty
5MB	1MB x 4	256KB x 4
8MB	1MB x 4	1MB x 4
12MB	2MB x 4	1MB x 4
16MB	2MB x 4	2MB x 4
16MB	4MB x 4	Empty
17MB	4MB x 4	256KB x 4
20MB	4MB x 4	1MB x 4
24MB	4MB x 4	2MB x 4
32MB	4MB x 4	4MB x 4
64MB	16MB x 4	Empty (No Good)
68MB	16MB x 4	1MB x 4
72MB	16MB x 4	2MB x 4
80MB	16MB x 4	4MB x 4
128MB	16MB x 4	16MB x 4

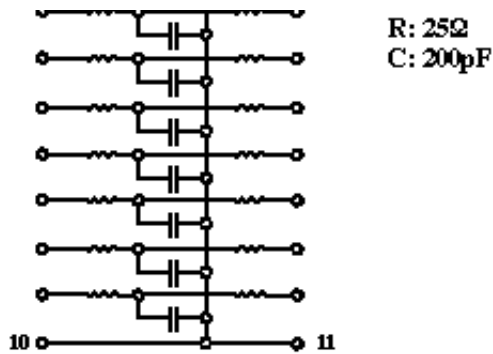
The diagram shows an RC Network T-Filter circuit. It consists of two resistors (R) in series with the signal path, and a capacitor (C) connected in parallel between the nodes between the resistors. The input is labeled 1 and the output is labeled 20.

find/obtain at resale parts shops. If you have a skill to make it yourself, refer the circuit schematic of the filter as shown in the left figure. It is made of sixteen 25 ohm resistors and eight 200pF capacitors. Assemble and solder them on a small IC socket, and then solder this socket on the logic board at reference RP2.

The culprit is the network filter located on the logic board at reference RP2. The model of the chip is Bourns 4120R-601-250/201, M/C 8908L 115-0002 or P9120M115-0006, depending on the lot, year and/or country where the logic board was made.
